# Navajo Abandoned Uranium Mine

# Site Screen Report

## Mesa V Adit AUM Site

March 2010

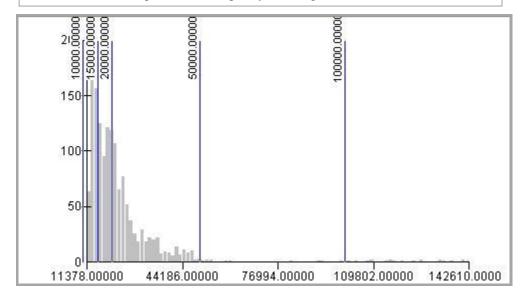
#### **Background Locations**

**Average background** = 15,200 cpm

#1 15,600 cpm

#1 14,400 cpm

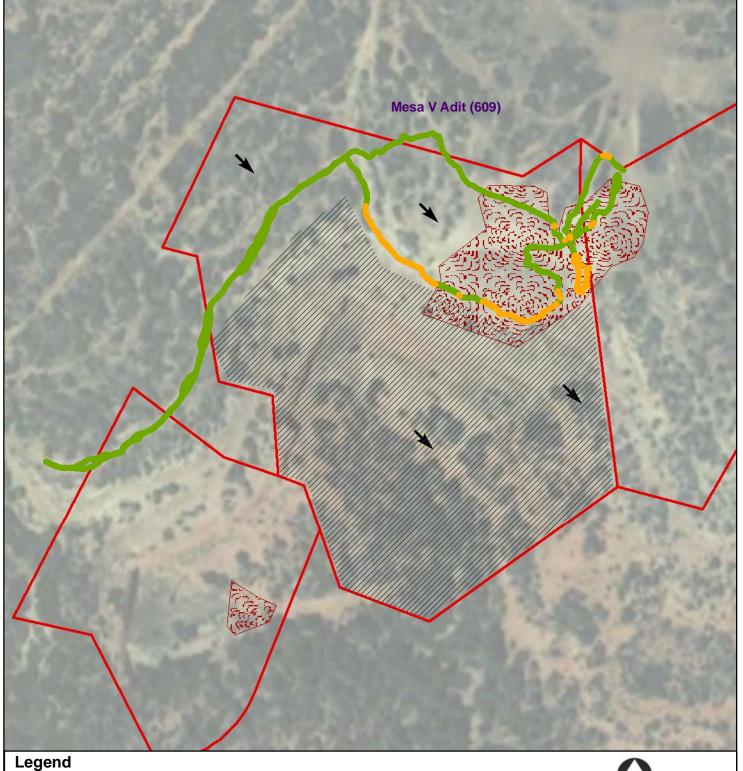
Figure 1 - Gamma Radiation Measurements, Above Two Times Background
Mesa V Adit (609)
Cove Chapter, Navajo Nation, Arizona

A total of 1,450 gamma radiation measurements were collected from the mine site, ranging from 11,378 cpm to 142,610 cpm. Measurements in the vicinity of the waste debris were found at levels up to 140,000 cpm. The measurements are represented in Figures 1 and 2.

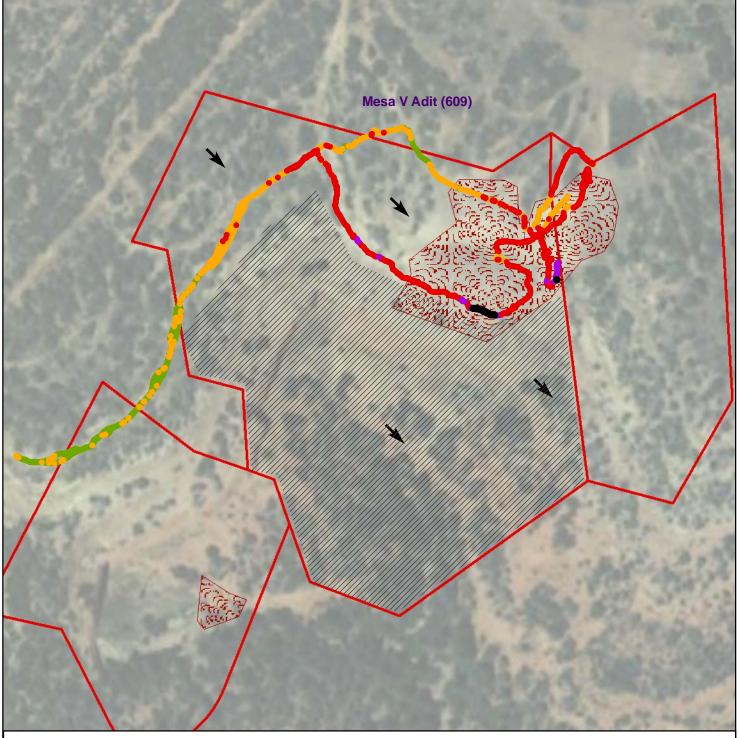
Figure 2 - Gamma Radiation Measurements Mesa V Adit (609) Cove Chapter, Navajo Nation, Arizona

Inaccessible due to steep grades
